# E N V I R O N M E N T A L B U L L E T I N

## **Mendums Pond Dam Repair Project Project Update & Nottingham Lake Notice – September 1, 2015**

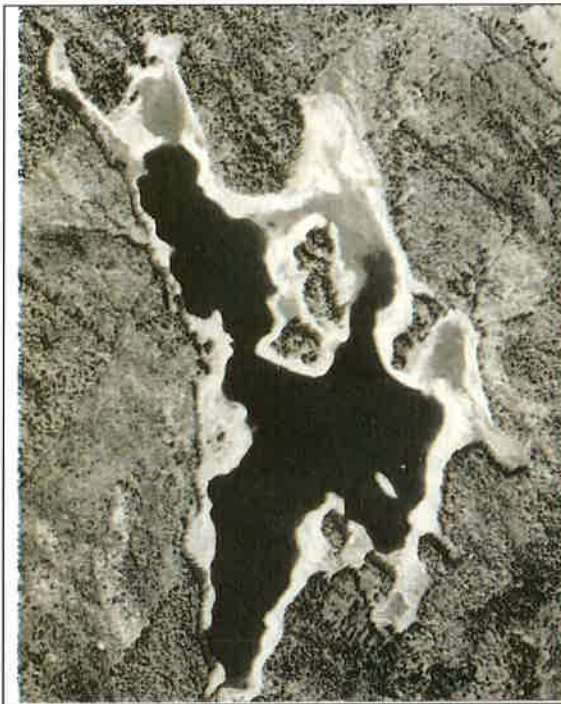
NHDES expects that the drawdown pond will look similar to the photo on the left side of the first page, which is an aerial image of the pond in 1942, after a drawdown of similar magnitude. It is expected that water levels will be allowed to rise again as soon as NHDES determines it is safe to do so considering the repair work being conducted in 2016.

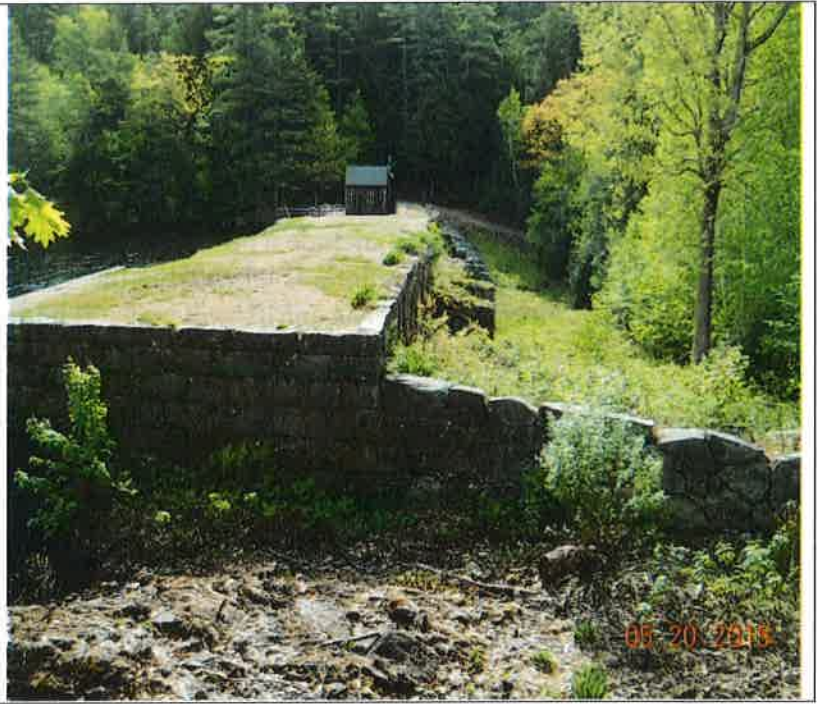
Additionally, NHDES is currently developing plans and specifications for the repair work. Current plans call for a repair that will include a downstream soil buttress and cutoff wall. The photo to the right side on the first page of this bulletin is taken from the spillway along the right side (looking downstream) of the structure. The cutoff wall and soil buttress will be installed on the downstream face of the dam (the area to the right in the photo).

The cutoff wall will be used to cutoff the leakage currently exiting the dam, while a new downstream soil filter will drain any seepage still passing through the dam or its foundation. The remainder of the soil buttress will act to stabilize the downstream face of the dam, and prevent future erosion and rotation of the downstream face. Current plans and estimates indicate that approximately 6,000 cubic yards of earthen materials (162,000 cubic feet) and approximately 400 cubic yards of concrete (10,800 cubic feet) will be used in the project. It is anticipated that this repair will not only preserve the safety of the existing structure, but will also allow for better access and easier maintenance. The completed repair will result in a safer site for the public as well, as the downstream soil buttress will eliminate many of the fall hazards currently present at the dam.
